## ***Power Station***

### **Unit #2**

## **Aperture slope/Extended side walls**

## **Fall 2022 Scheduled Outage Report 1.0**

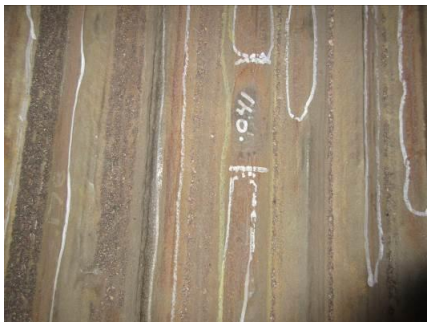
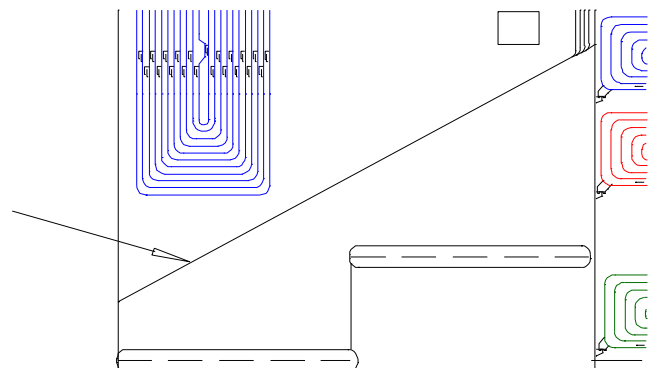
1. There is severe erosion to the tubes from the bend up 6' under the Finishing Superheats. This is at elevation 1124'-3" to 1128'-3". This erosion is in retract 9 L/R just under the finishing Superheats. The UT readings across the slope range from 0.041" to 0.174" of the original .250" MWT. There was tube failure on the slope that brought the unit off.

**Recommendation: Refer to the table below for repairs and locations**
