Energy Center Unit Z

Primary Superheater Inlet Pendants Inspection Report

Spring Outage

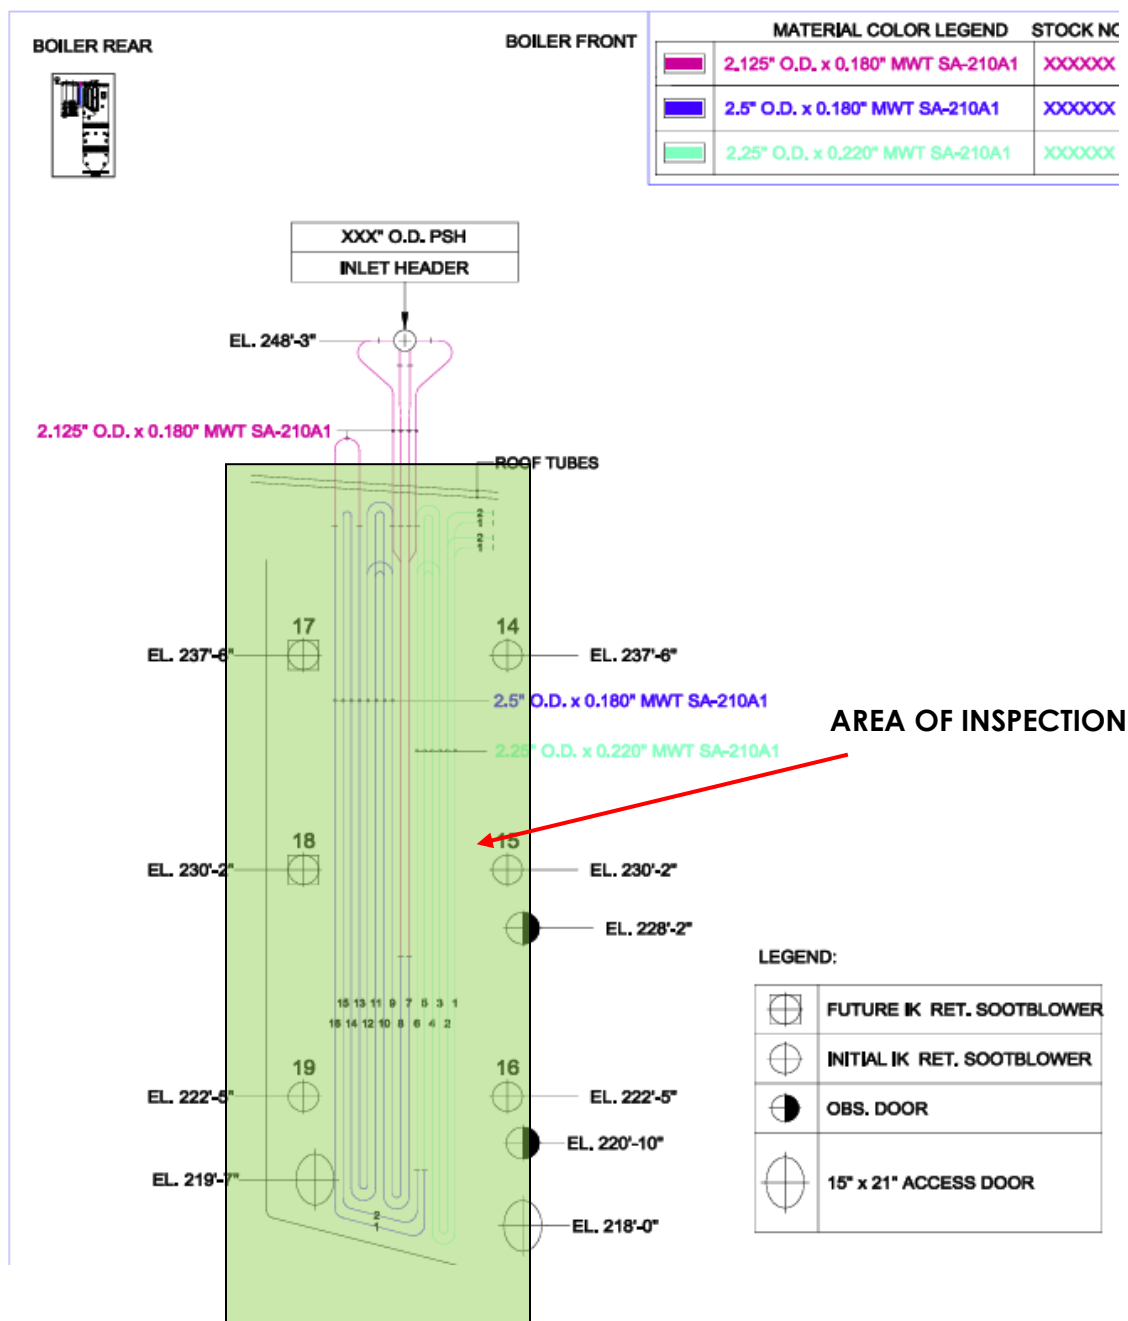
Item 1

There are (31) straight tubes experiencing moderate to severe sootblower erosion from SB-19 on the pendants listed below and 2 loops were severely eroded with UT's <60% remaining wall thickness.

Pendant	Tube	UT	Pendant	Tube	UT
2	4	0.124"	45	4	0.128"
7	6	0.123"	46	6	0.130"
10	5	0.127"	47	5	0.118"
11	6	0.125"	48	5	0.126"
11	7	0.130"	49	5	0.114"
13	4	0.124"	52	3	0.135"
18	4	0.128"	52	4	0.117"
19	7	0.128"	53	3	0.120"
23	4	0.135"	53	4	0.137"
24	5	0.130"	53	5	0.121"
25	4	0.108"	54	5	0.133"
25	4	0.140"	55	Loop #1-ISB	0.083"
27	4	0.130"	55	Loop #2-ISB	0.100"
27	5	0.134"	55	3	0.061"
31	5	0.130"	55	4	0.086"
32	5	0.087"	55	5	0.104"
32	6	0.125"	56	3	0.120"
38	5	0.077"	56	4	0.125"
39	4	0.124"	56	5	0.134"
40	6	0.128"	57	3	0.119"
42	4	0.131"	57	7	0.136"
43	5	0.131

NOTE: Shields were previously installed on the last 3 tubes and some of the erosion on tube 3 was located directly under the shield.

Repair Recommendation: Once the alignment bar was removed and (32) areas of severe erosion was centered in the IK-19 lane. Install (30) 5' straight dutchman with location noted in table above.

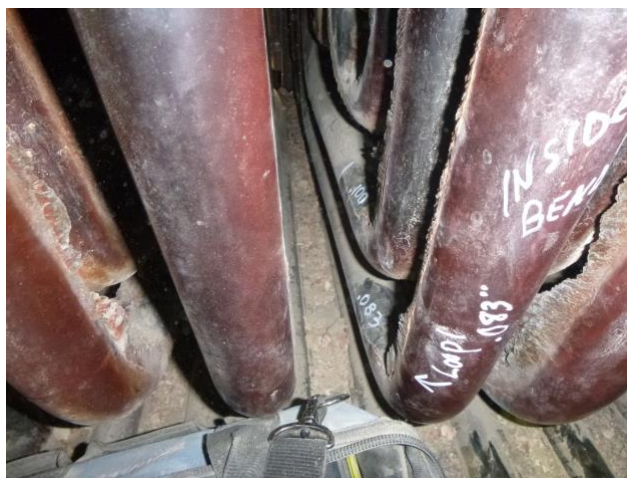
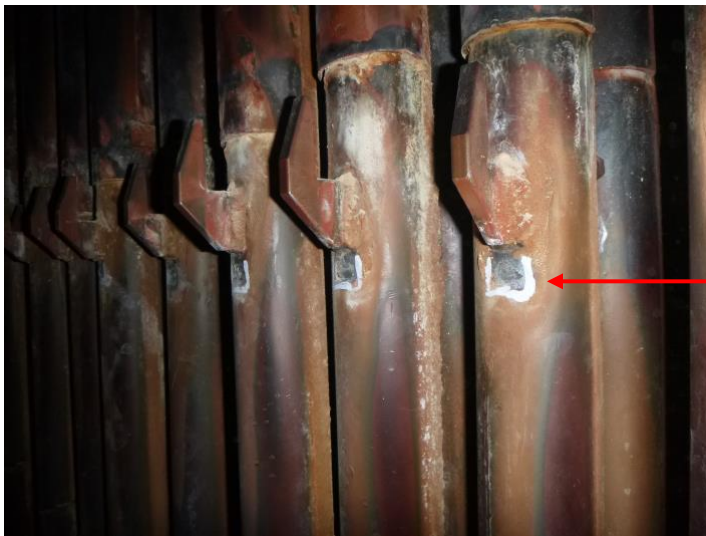
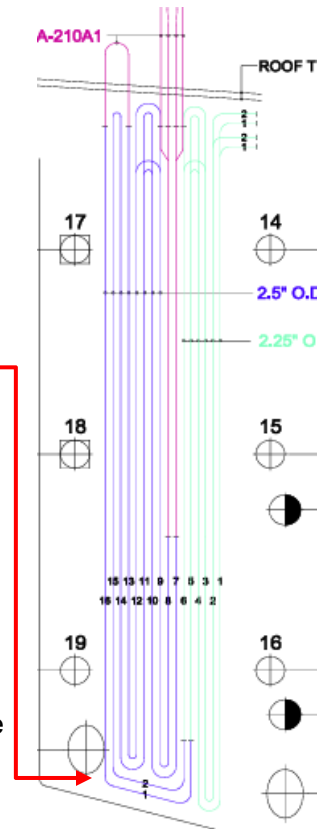
Item 2

There are (57) areas of moderate to severe sootblower erosion located on the underside of the rear alignment bar lugs were moderate on pendants 1-20 and severely eroded on pendant 21-57 (tube 16/last tube). This is due to the SB-19 lance channeling under alignment bar.

Note: The alignment bars were removed to gain access allowing additional inspections to be able to obtain a better depth of the SB erosion.

Repair Recommendation: Install (57) 2" x 2" padwelds on the rear of tube 16 (last tube) located underneath the alignment lugs due to IK -19.

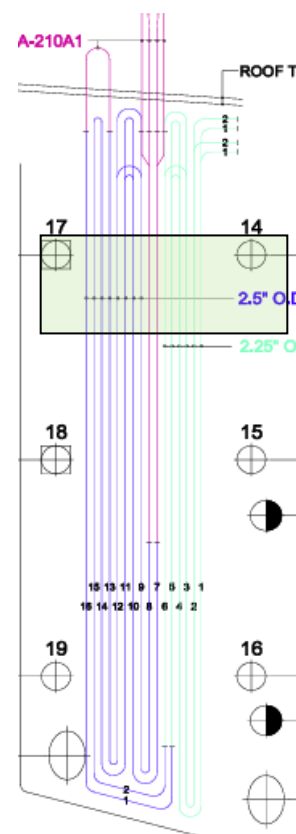
Item 3

There are (12) areas experiencing moderate to severe sootblower erosion from (SB-14) located on the front side of the primary superheater inlet pendants at the roof (Scaffold level 4/Top). The thickness readings ranged from 0.154" to 0.107" of the original 0.220" MWT.

Pendants	Tb	UT	Repair/Comments
Scaffold Level # 4 (top)			
48	5	Eroded Hole in Shield	Install 36" Shield
49	5	Eroded Hole in Shield	Install 36" Shield
50	4	Eroded Hole in Shield	Install 36" Shield
51	3	0.107"	Install 4' dutchman
52	5	0.115"- 0.130"	Install 4' dutchman
53	3	Eroded Hole in Shield	Install 36" Shield
53	4	0.115"- 0.130"	Install 4' dutchman
56	3	Eroded Hole in Shield	Install 36" Shield
Scaffold Level # 2/3			
3	3	N/A	Install 4' dutchman
3	7	N/A	Install 4' dutchman
55	5	N/A	Install 4' dutchman
55	6	N/A	Install 4' dutchman

Tube Material: 2.25" O.D. x 0.220" MWT SA-210 A1

Repair Recommendation: Install (7) 4' dutchmen on the pendants listed in the table above. Install (5) 36" straight shield on the rear of tubes (3, 4, or 5) due to IK -14.

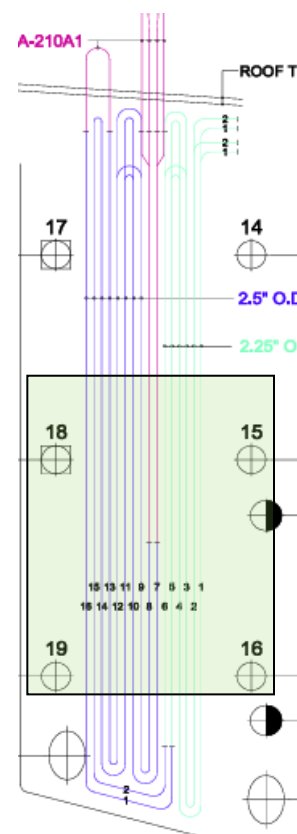
Item 4

There are (5) areas / tubes experiencing moderate to severe sootblower erosion from (SB-15 & SB-16) located on the front side of the primary superheater inlet pendants (Scaffold level 2/3). The thickness readings appear to be <70% with lowest UT reading of 0.140" of the original 0.220" MWT.

Pendants	Tb	UT	Repair/Comments
Scaffold Level # 2/3			
3-25	7	Moderate / Severe Erosion (0.140")	Spread pendants to gain access.
49	3	0.164"	
51	3	N/A	
52	3-4	N/A	
53	3-5	N/A

Tube Material: 2.25" O.D. x 0.220" MWT SA-210 A1

Repair Recommendation: Once the racked pendants are let loose call for a re-inspected.
