Energy Center Unit Z

Primary Superheater Inlet Pendants Inspection Report

Spring Outage

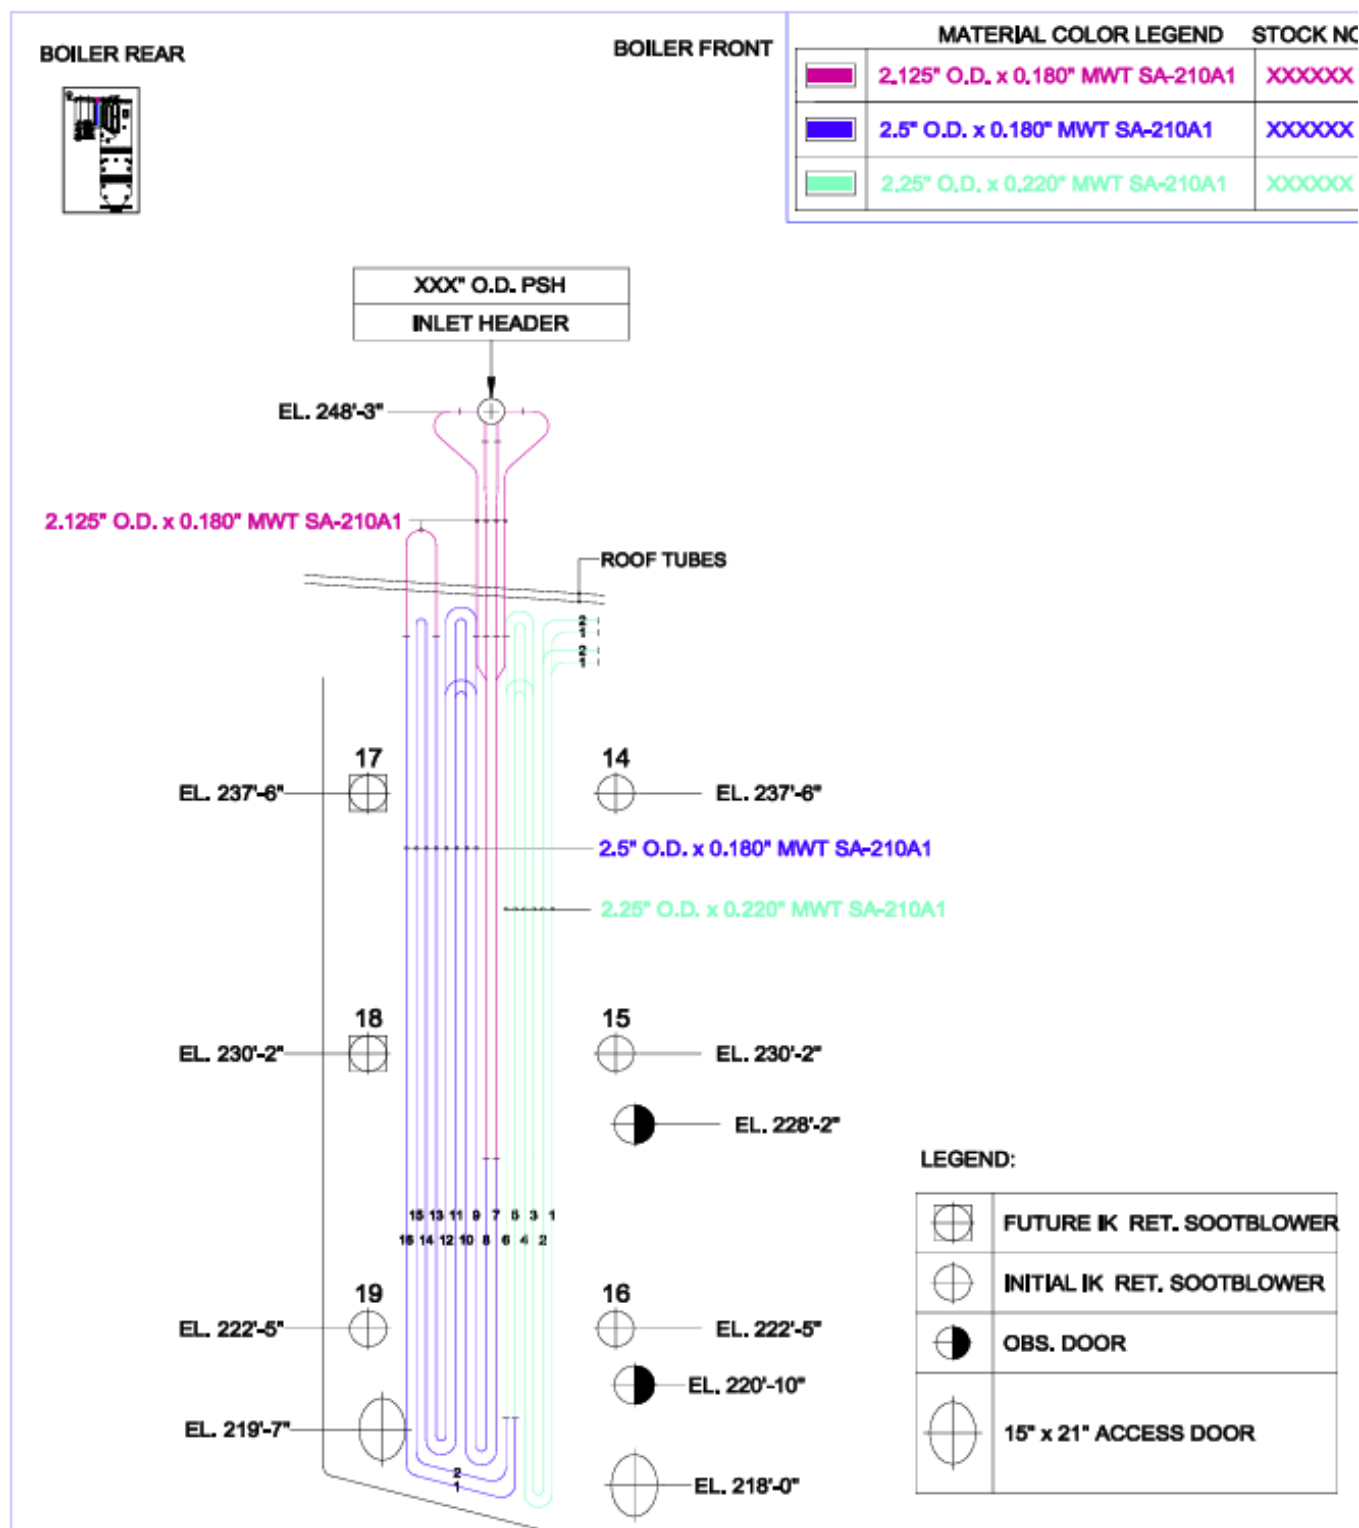
Item 4

There are (5) areas / tubes experiencing moderate to severe sootblower erosion from (SB-15 & SB-16) located on the front side of the primary superheater inlet pendants (Scaffold level 2/3). The thickness readings appear to be <70% with lowest UT reading of 0.140" of the original 0.220" MWT.

Pendants	Tb	UT	Repair/Comments
Scaffold Level # 2/3			
3-25	7	Moderate / Severe Erosion (0.140")	Spread pendants to gain access.
49	3	0.164"	
51	3	N/A	
52	3-4	N/A	
53	3-5	N/A

Tube Material: 2.25" O.D. x 0.220" MWT SA-210 A1

Repair Recommendation: Once the racked pendants are let loose call for a re-inspected.
